# Manhole Inspection Summary

Manhole # S01GG2012MH

Record Plat: **01GG2** Node: **012** Status: **New Manhole (Not in GIS)** Insp Date: **8/8/06 12:00 AM**

**Location** Address: **3031 Fallstaff Rd**

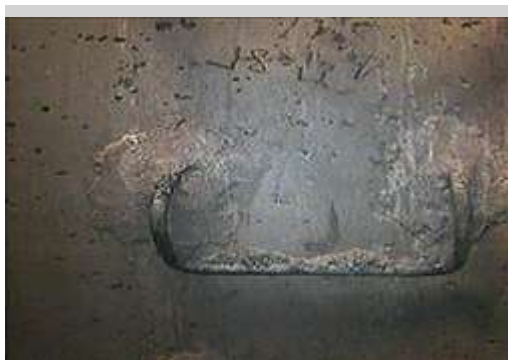
Defect

**Steps** Count: **8** Missing: **2** ☐ Corroded

bent step (typ. of 2)

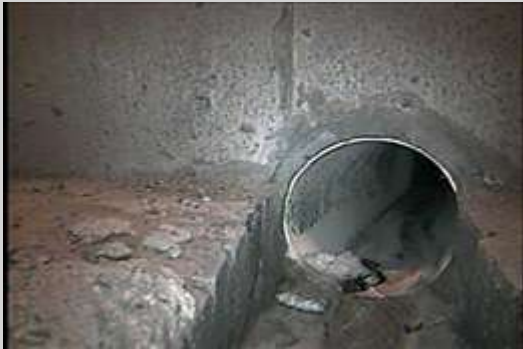
### 8 in. Circular Gravity Sewer Pipe Out @ 12 O'Clock

pipe lined

Deposits: ☐ None ☐ Mud ☐ Sludge ☒ **Debris** ☐ Grease

Silt Depth: **0** (in.) Deposits Extent: **Light**

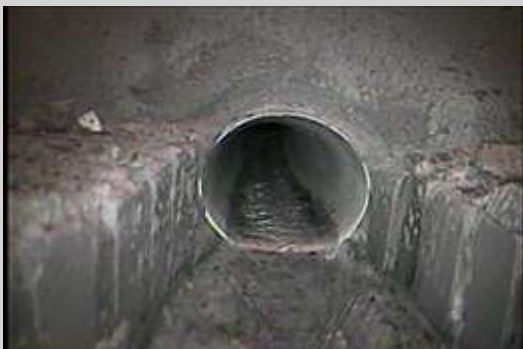
### 8 in. Circular Gravity Sewer Pipe In @ 4 O'Clock

pipe lined
